## A House For All Seasons: The Five Mile House

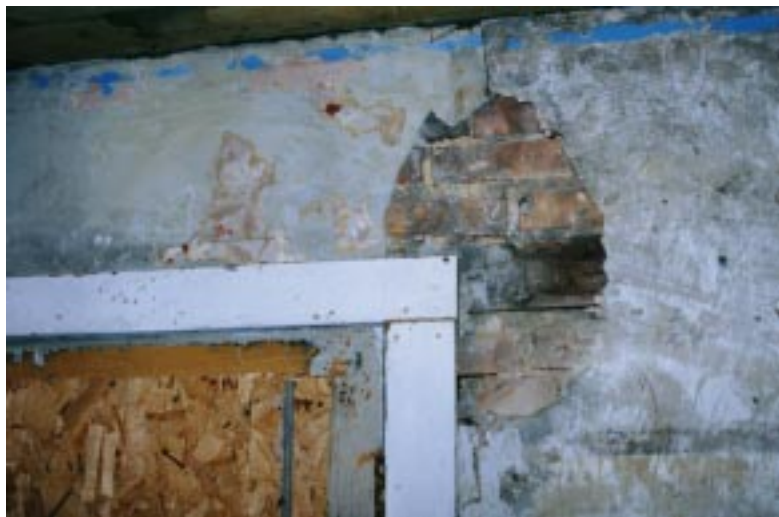
Deteriorated and chipped plaster over the doors and windows on the north and south walls reveals hewn wooden lintels. Rather than having individual lintels, a single 4 1/4 inch high lintel on each wall stretches more than 9 ½ feet over each door and window combination (Fig. 3). The

**Fig. 3. A single hand-hewn lintel stretches across each door and window combination in the east room addition.**

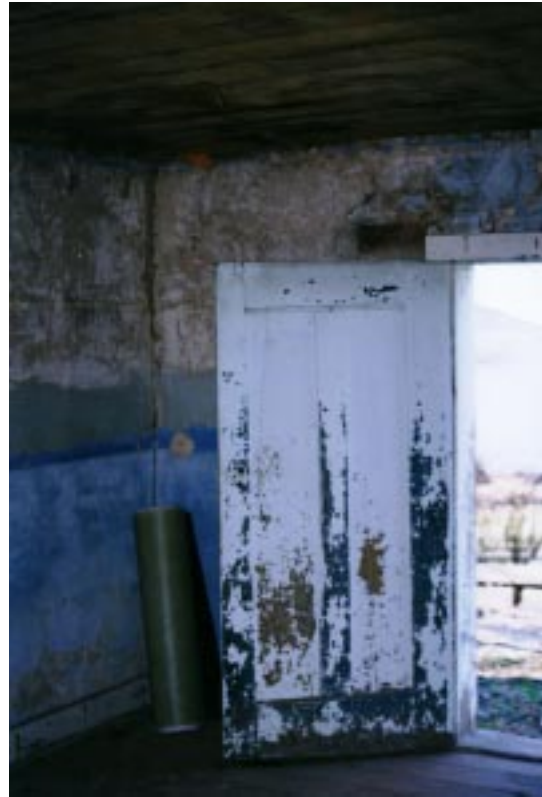
**Fig. 4. This blue and tan two-panel door probably is original to the east room addition of the house.**

inch door has flaking white paint over blue paint on the door's stiles and rails and tan paint on the inset panels (Fig. 4). The door, which is attached with two hinges, probably survived because it was protected from the weather by the added kitchen ell. Also, because the door was an inside door when the house's other exterior doors were replaced in the late 19<sup>th</sup> or early 20<sup>th</sup> centuries, there was little aesthetic reason to upgrade it at the same time.

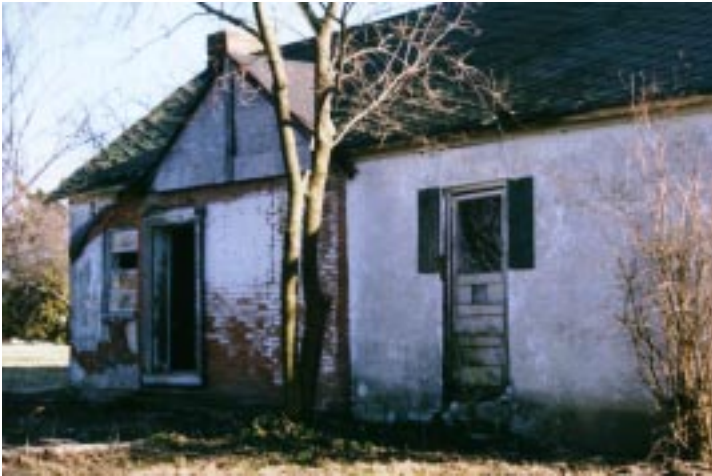
**Fig. 5. The north side of the house still shows plenty of evidence of the removed kitchen ell.**

gable roof remains attached a little below the ridge of the main part of the structure; however, the ell's roof was truncated at the edge of the brick building (and the resulting opening boarded up) when the ell was removed (Fig. 5).

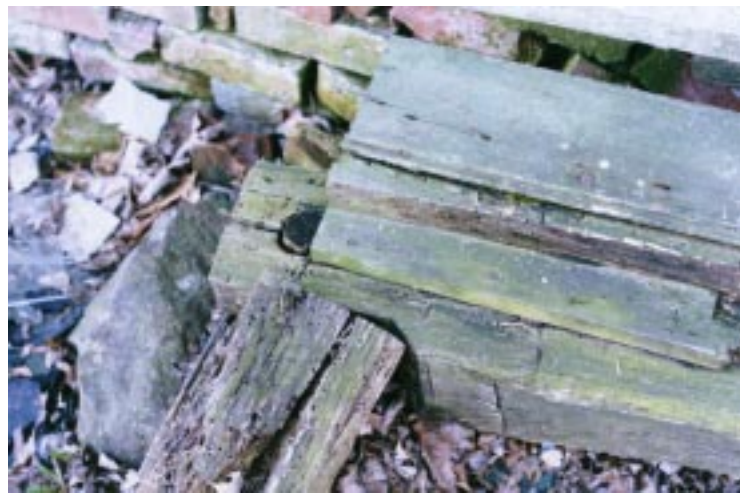
The size of the remaining timbers suggests the addition used braced frame construction techniques. The remaining sills on the north and south sides are 7 inches wide and six inches deep. The remaining sill on the east side is 6 inches square. The ell remnants include a partial loose concrete block foundation with hand-hewn wooden sills still in place on the north, east, and south sides. The remaining sills were horizontally half-lapped at the ell's corners and secured with wooden pegs, also known as treenails (Fig. 6). Square nails remain in the sills and in a couple of remaining floor beams. The floor

**Fig. 6. The remains of the kitchen ell include these wonderfully joined pieces of the old sills.**

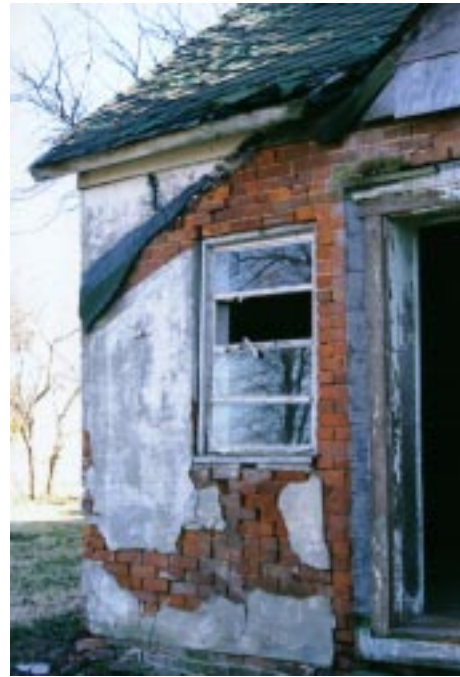
A roof slope outlined with tar and shingle paper on the side of the brick addition on the east side of the kitchen ell is evidence of a covered porch in the corner formed between the rooms. The porch probably was unenclosed because, unlike in the kitchen ell, the east room's exterior brick wall is stuccoed over in the porch area (Fig.

**Fig. 7. The shingle paper tarred above the window on the northeast corner of the house is evidence of a kitchen ell porch.**

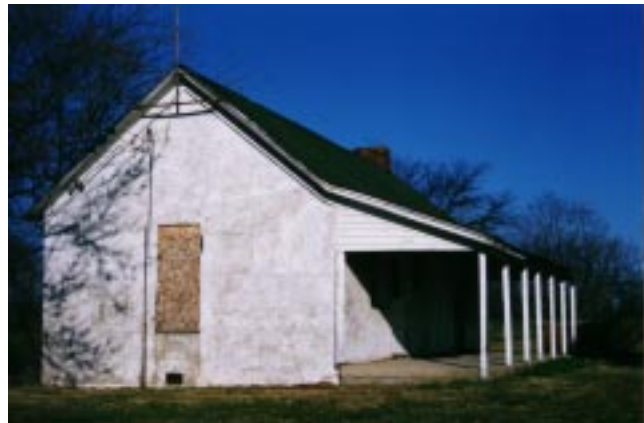
**Fig. 8. The Five Mile House has a full-width porch on its front (south) side**

round nails became available in about 1880. The seven porch posts across the front of the porch have been replaced with modern lumber, but the two 3 ½ inch square posts closest to the house are original to the porch and sport decorative chamfered corners (Fig. 8). The porch has a decorative concrete block foundation and currently has a poured-in-place concrete slab floor. The porch also has hooks screwed in the ceiling to support a porch swing.

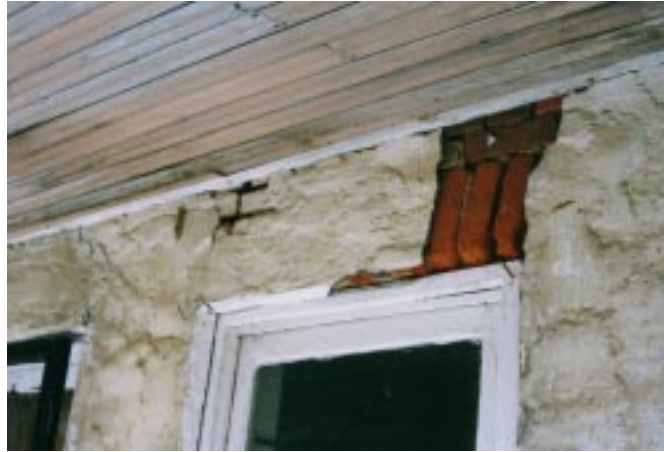
**Fig. 9. Fallen stucco reveals a decorative flat brick arch over the south window in the east room addition.**

house with mirror image doors and windows on each side. Another impressive architectural feature is the flat brick arch over the front window in the east addition (Fig. 9). This is purely a decorative feature, as the structural element supporting the wall above the 45 by 29 ½ inch window opening is a hewn wooden beam mentioned earlier in the interior east room description. The window opening at the rear of the brick addition is 44 ½ by 29 inches and does not have a flat brick arch. Unfortunately, the windows in the original room of the house are well stuccoed over, concealing the presence (or lack of presence) of flat brick arches. The window on the south side of the west room is 45 ½ by 28 ½ inches. The window on the west side of the older room is boarded up, preventing an accurate measurement from the interior.

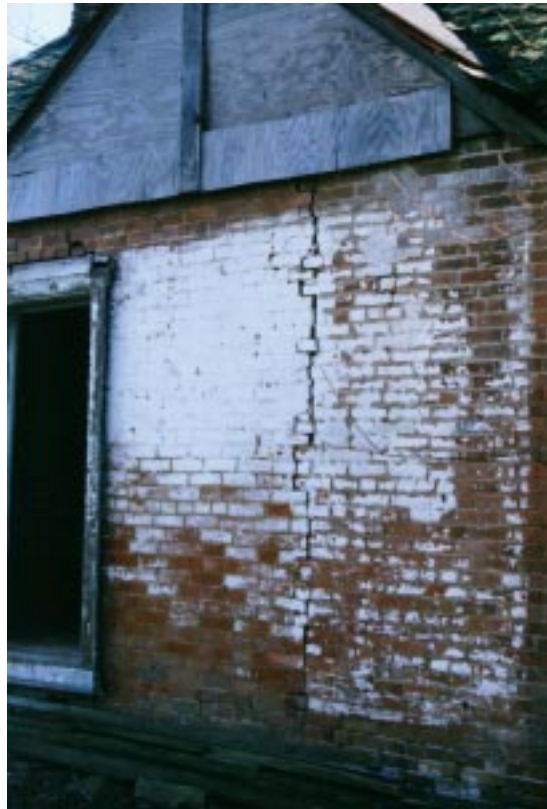
location of the interior wall, it is apparent that the joint is at the east side of the interior wall. This shows that the interior wall originally was an exterior wall for the west room and that the east room was added later (Fig.10). This section of wall also offers some other interesting construction details. The bricks in the old and new sections are of slightly different sizes. Although all of the bricks are quite irregular, the bricks in the original structure measure about 8 ½ by 2 inches while the bricks in the newer addition measure about 8 1/8 by 2 ¼ inches. And, although both rooms use forms of the American Bond pattern, the older section has five rows of stretchers between rows of headers while the newer section has anywhere from five to seven rows of stretchers between rows of headers.

**Fig. 10. This crack shows where the east room was added on to the original one-room brick house. The wall was not stuccoed here because it was protected by the kitchen ell.**

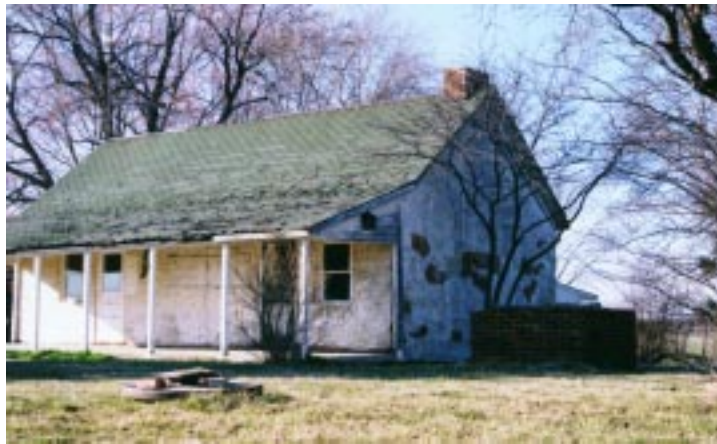
Coles County, Illinois. The property currently is bounded by Illinois Route 130 on the west and by Westfield Road on the south and by fence rows on the east and north sides. A decayed wooden fence post and the remains of an iron pipe fence post are visible about 15 feet west of the current east fence row suggesting that the fence row might have been relocated at some point in time. Three water wells are visible. The currently used well, which is about 13 ½ feet due east of the south edge of the Five Mile House's front porch, is surrounded by a modern rough-faced, two-hole brick wall about 6 feet square and 3 feet high. Two earlier wells are covered by circular iron-rimmed concrete pads, which are 3 feet 5 inches in diameter, and have a small hole for the long-removed pumps. One is 39 feet southeast of the house and the other is 28 feet due north of the east side of the house (Fig. 11).

**Fig. 11. Two wells are visible in this image: The current well is in the brick enclosure to the right of the house and an earlier well is in the left foreground.**
