## A House For All Seasons: The Five Mile House

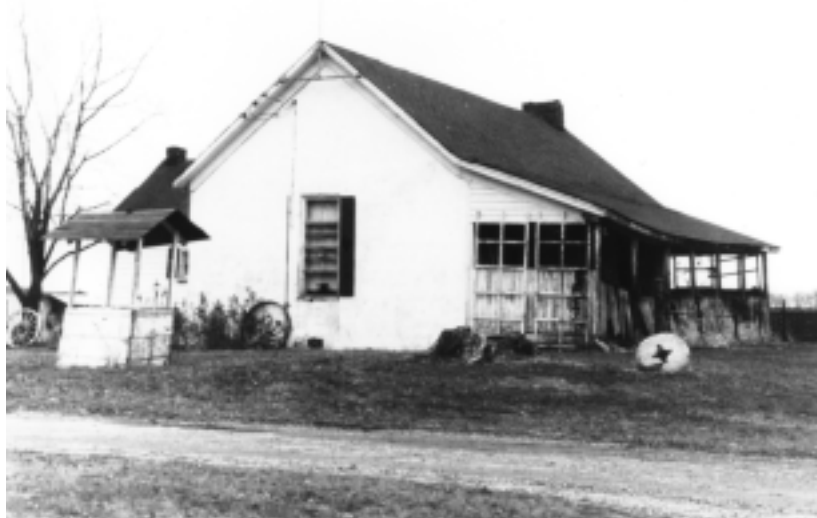
**Fig.1. The Five Mile House sometime in the early 20<sup>th</sup> Century sported an enclosed porch and a probably fake well. Note also the kitchen ell with its gable end chimney.**

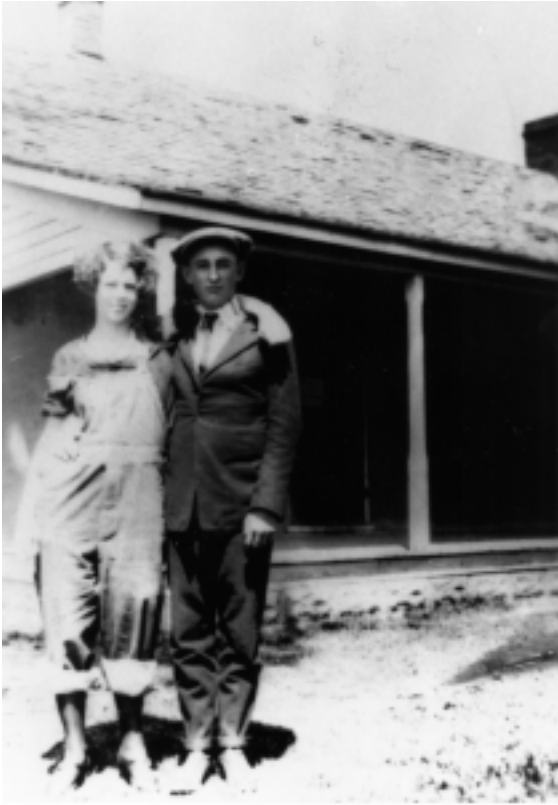
**Fig. 2. A small chimney is visible rising out of the middle of the west room above the couple in this early 20<sup>th</sup> century photograph.**

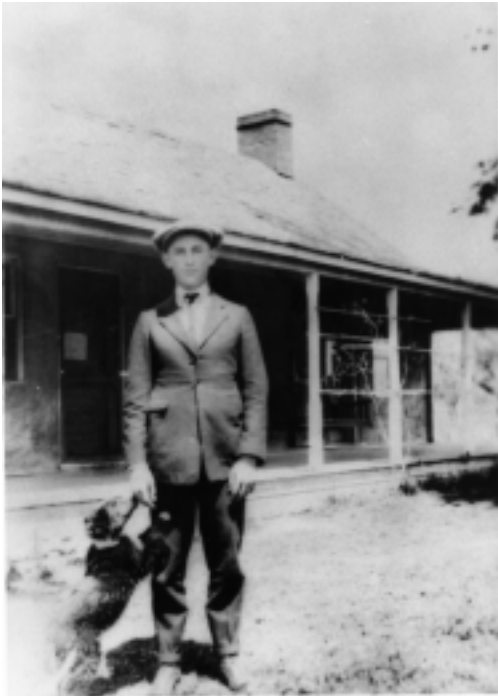
**Fig. 12.** As this early 20<sup>th</sup> Century photograph shows, the Five Mile House is a link to Coles County's historic past.
